Manhole Inspection Summary

Manhole # S53I__016MH

Insp Date: **4/11/08 11:20 AM**

Location Address: **3113 eastern ave**

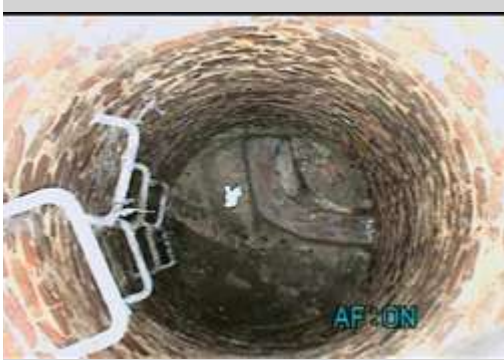
Defect 1

Count: **7** Missing: **0** ☒ **Corroded**

steps

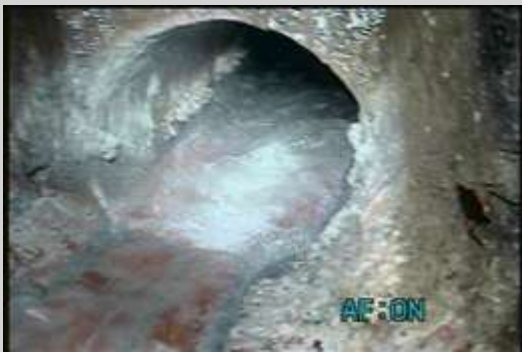
12 O'Clock Outflow

8 in. Circular Gravity Sewer
Pipe Out @ 12 O'Clock

Invert Depth: 11.63 (ft.) Flow Characteristics: Fast

Infiltration: None Pipe Seal Cond: Unknown

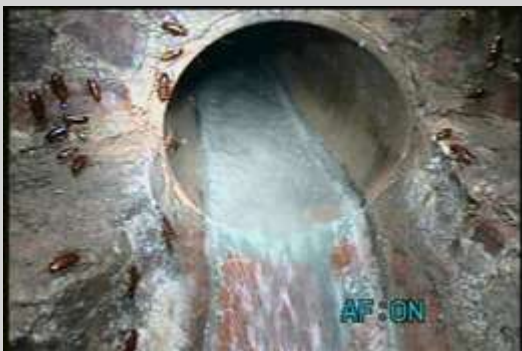
3 O'Clock Inflow

6 in. Circular Gravity Sewer
Pipe In @ 3 O'Clock

Invert Depth: 10.88 (ft.) Flow Characteristics: Fast

Infiltration: None Pipe Seal Cond: Unknown
